## 7.0 ARCHAEOLOGY

### 7.1 EXCAVATION IN ROOM 103

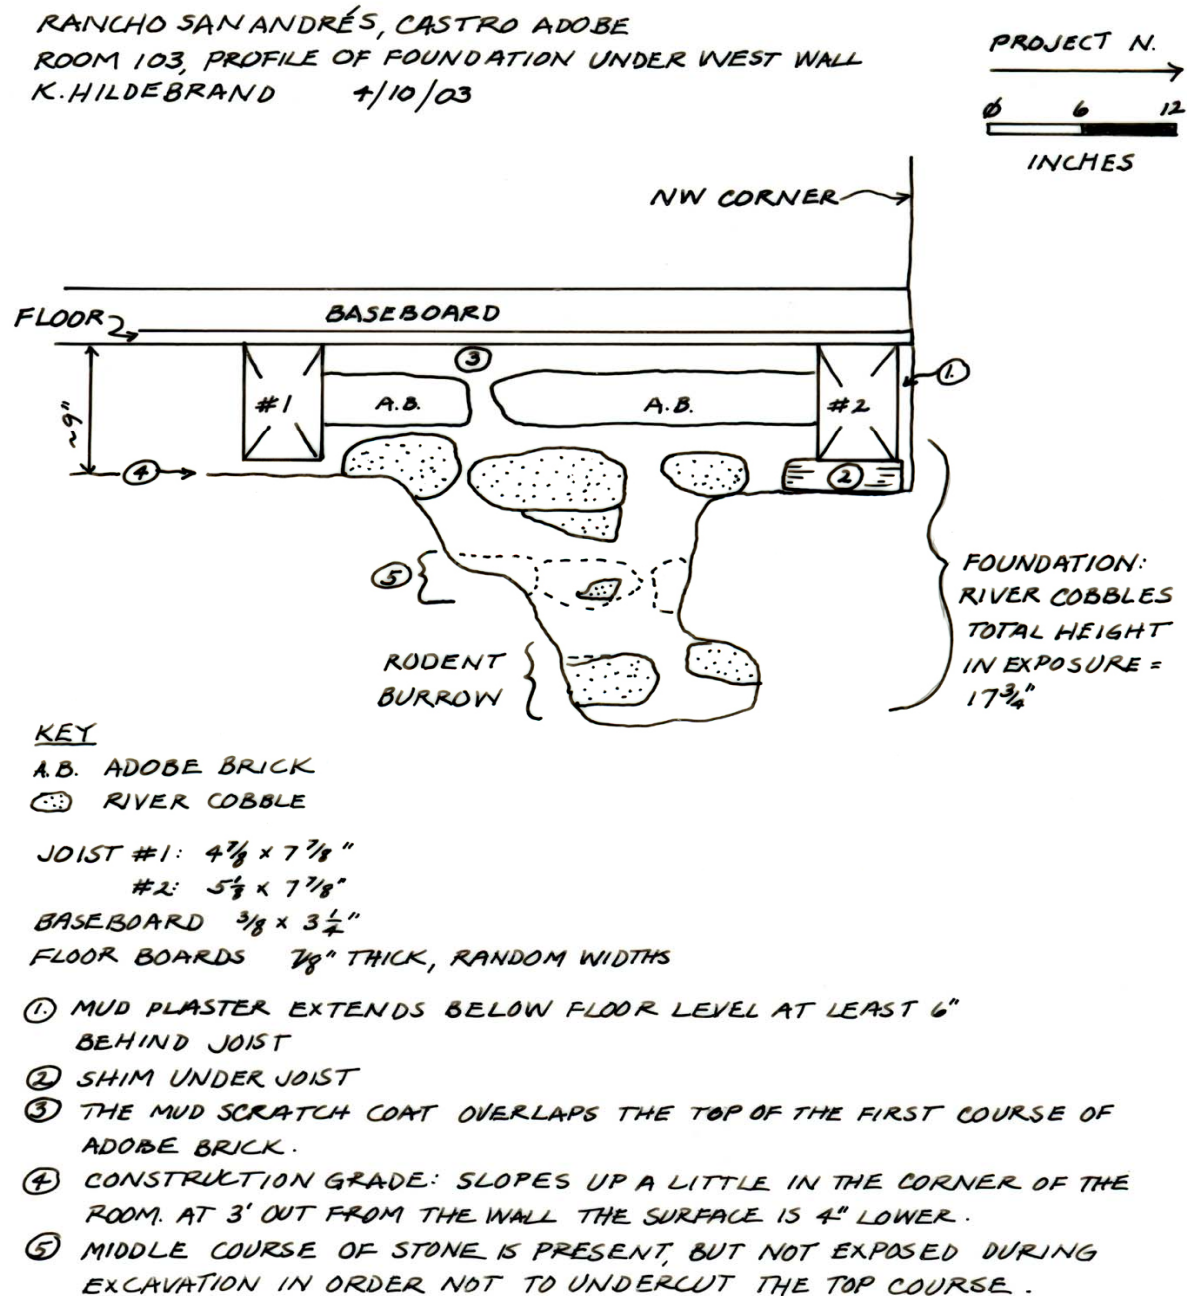
**Figure 7.1** Profile of foundation under west wall of Room 103 showing foundation.

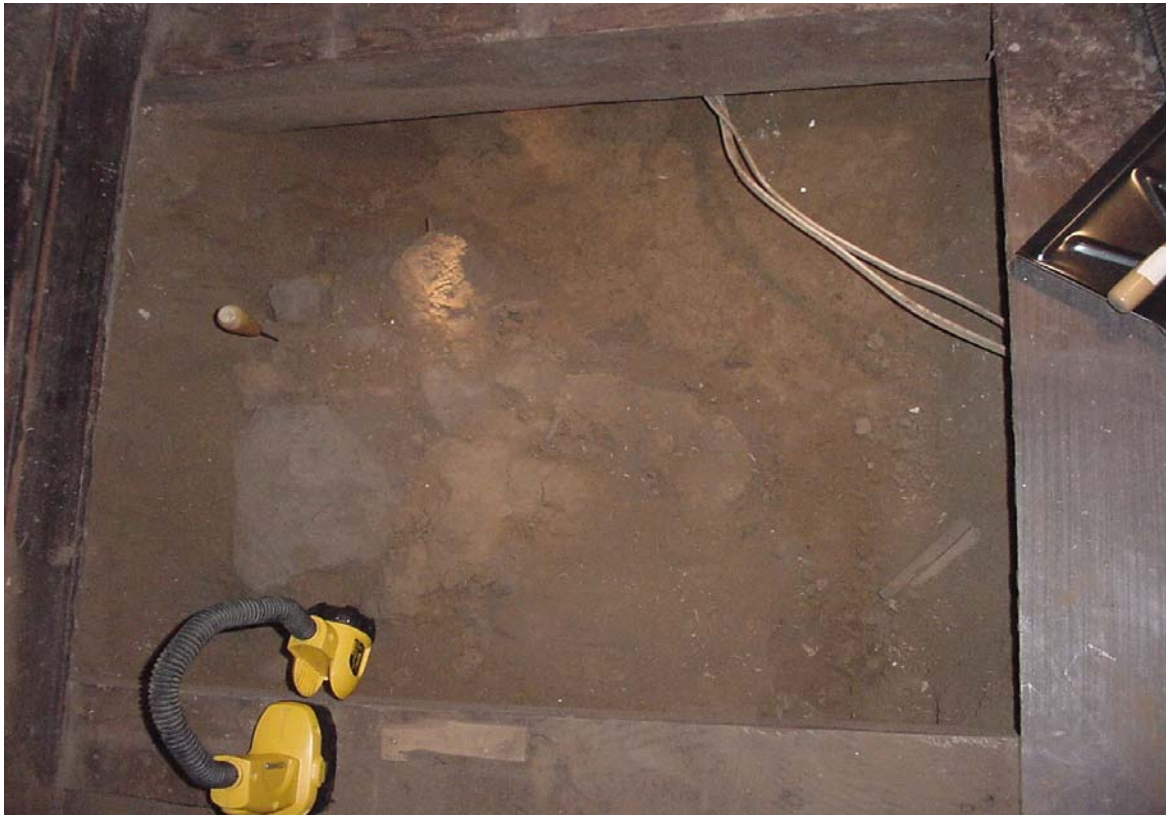
**Figure 7.2** Construction debris beneath floor of Room 103: broken adobe bricks, mud plaster, etc..

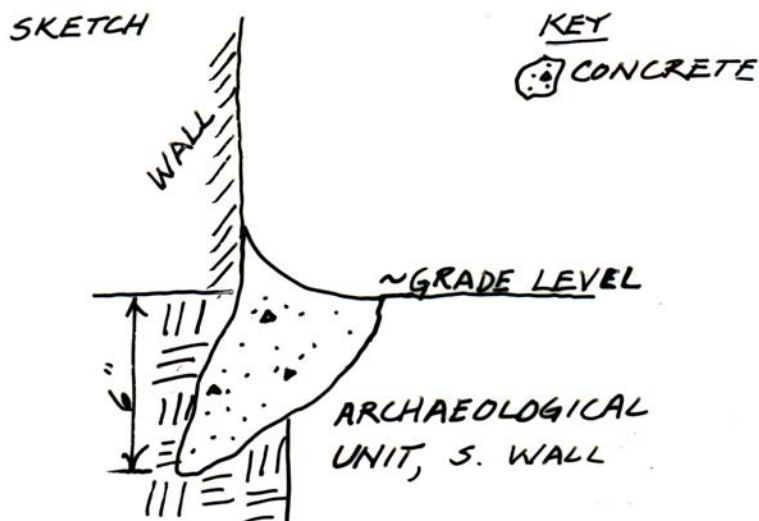
ELEVATION, CONCRETE LEDGE (CONTRAPARED)  
NEXT TO BASE OF WEST COCINA WALL

At the base of the wall, a concrete ledge (profile sketched in Figure 7.4) was broken out within the unit in order to expose the full foundation. This irregularly shaped concrete repair might be considered to be a contrapared. It lips up the wall 2 to 3"; the roughly triangular shape rests against an irregular wall surface that does not look like coving from basal erosion. This is probably an attempt to keep surface water away from the base of the wall.

Figure 7.4 Elevation next to west cocina wall showing concrete apron.

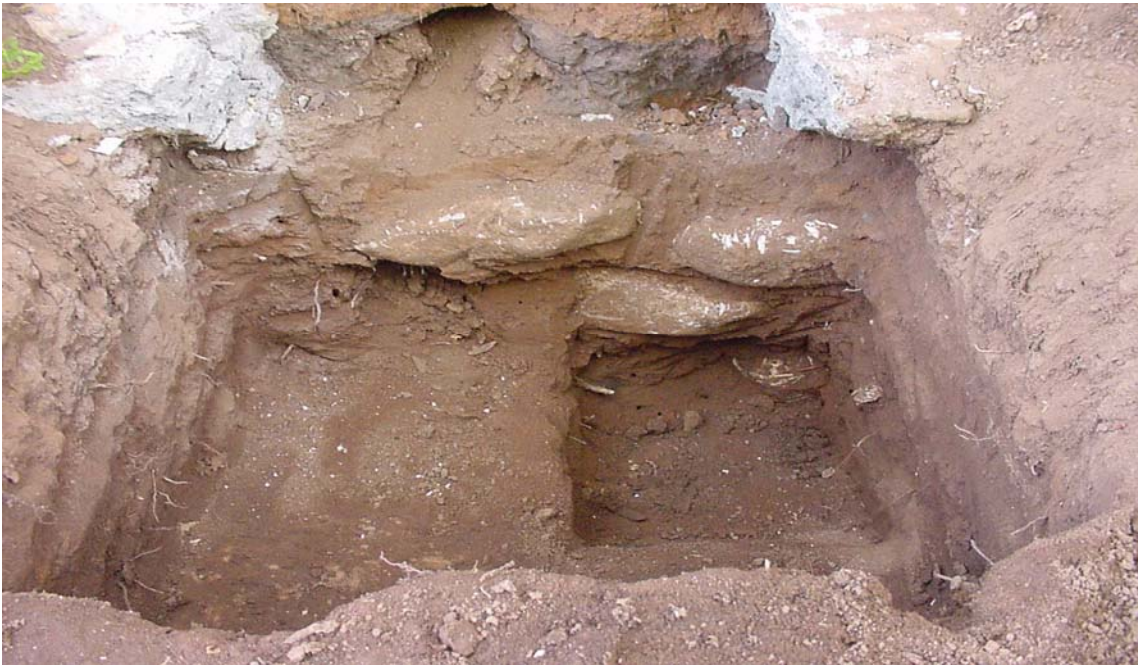
**Figure 7.5** View of foundation stones at exterior of cocina (Room 101) facing east.

Figure 7.5 is a photograph of the foundation under the west wall of the cocina. The foundation has three courses of cobbles; total height here is 14", with the top at 6" below existing grade and the bottom at 20". The bottom of the adobe wall is 4-3/4" below grade which comes close to coinciding with a 4" thick layer of added top soil. The adobe wall would have been completely exposed, and perhaps the top course of the foundation as well (as is the case on the interior of the cocina.) Comparison of elevations could verify this.

Rodent (gopher) tunnels penetrate the first and second courses of the adobe brick wall within the unit. The tunneling has already been noted on the interior side of the foundation in Room 103. This damage is probably an impact throughout the building.
